29 EXAMPLE ST, OBSERVATORY

CONDITIONAL SURVEY WITH ESTIMATES

FULL PROPERTY CONDITION AUDIT WITH ESTIMATES

Date: 31/10/2023

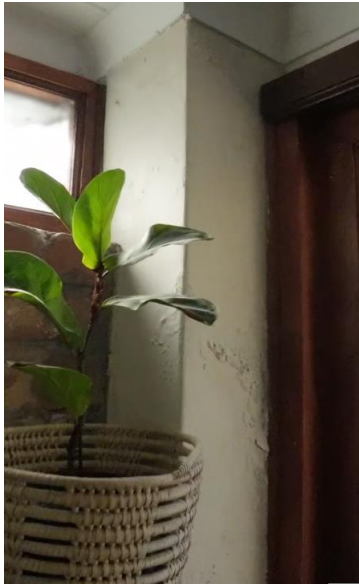
BILL OF ITEMS**DAMP IN KITCHEN CORNER**

Waterproofing issue, seems to not be resolved

Leak Detection: R1500

Rewaterproofing: R3500

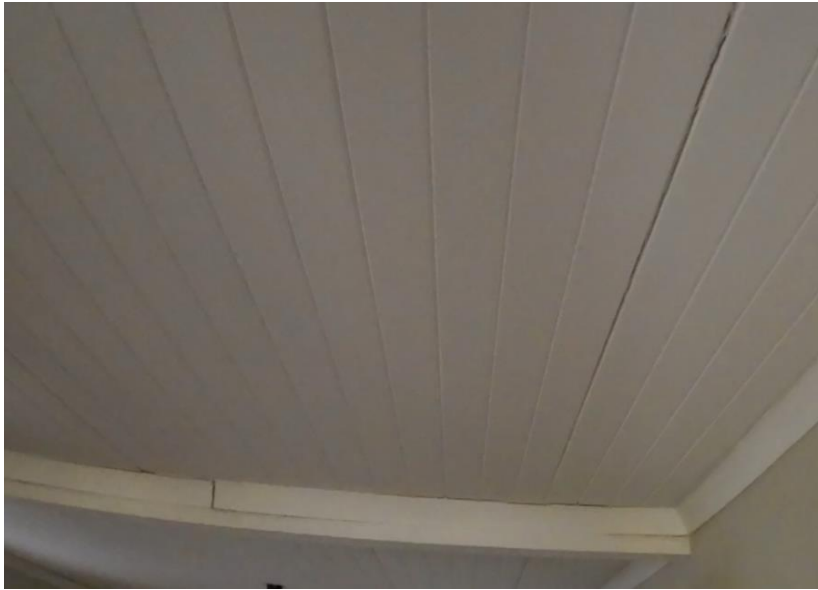
**CRACKS IN BATHROOM BEHIND KITCHEN**

Possible structural damage from building extension, not evident all over same line

CEILING BOARD SEPARATION – KITCHEN

Investigation and repair: R6500

Soft joint installation R3500

Resealing joints and re-fixing loose components: R3000

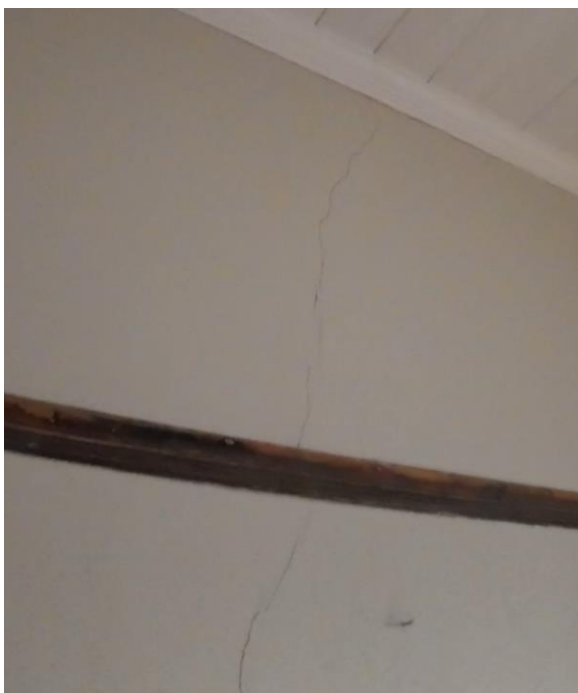
CRACK BEHIND FIREPLACE - MAIN BEDROOM

Possibly structural as crack is evident beyond the plaster, this could be a bigger issue if not taken care of. Assumption could be made that the crack was caused by excessive heat from the fireplace, which is the best case as long as the crack doesn't travel into the foundation. New steel members need to be installed to increase tensile strength and replace

Demolition and structural repair: R10'000

Replaster and repaint: R5000

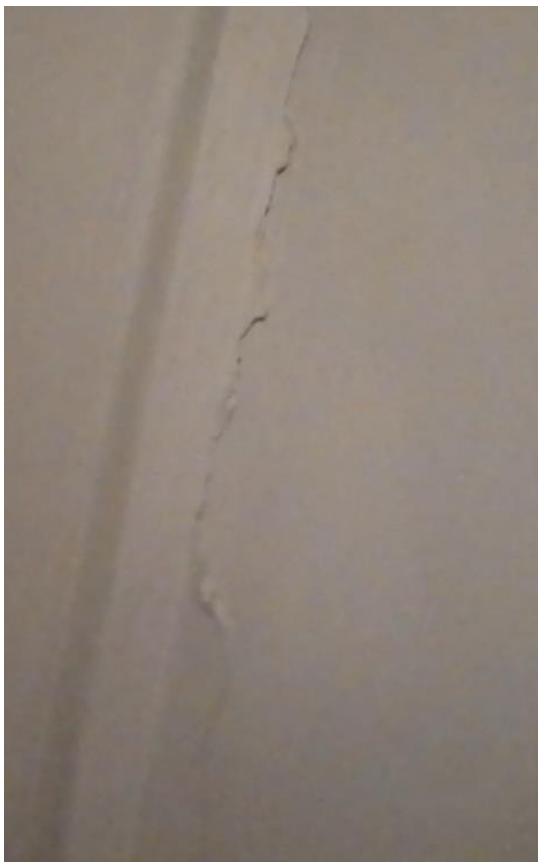
REPAINTING - MAIN BEDROOM

DAMAGED AND SAGGING TIMBER BOARD CEILING IN LIVING ROOM

DAMAGED CEILING – STUDY

Full repaint required because of damaged elements: R5000

Replace ceiling with isoboard: R15'000

Fill and paint, repaint whole ceiling: R3000

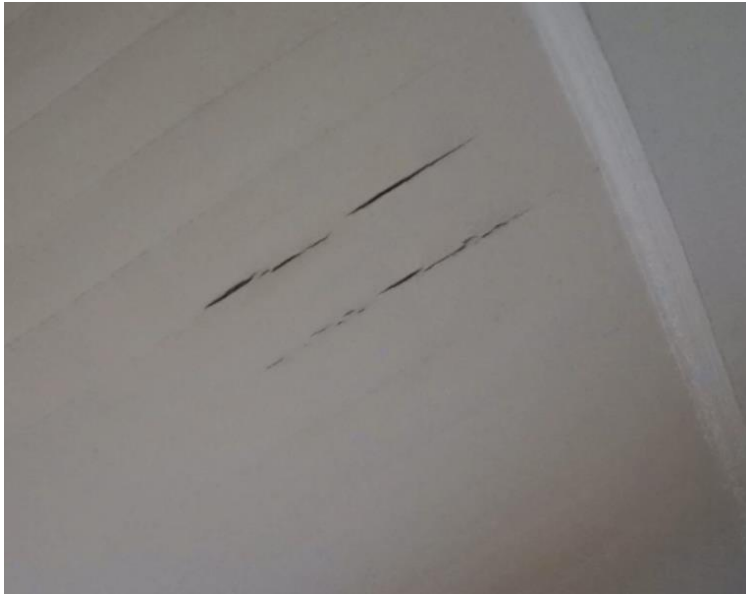
CRACKS ON PASSAGE ARCHWAY

CRACKED PLASTER – GUEST ROOM

No evidence of cracked wall, moisture and poor surface prep may have led to delamination

Open and investigate cracks, structural steel embedding repair and repaint: R5000

Break out loose area, reskim and repaint: R5000
