### **EXAMPLE BLOCK**

19 Example Rd, Vredehoek, Cape Town, 0000

Date: 26 January 2024

### **REPORT**

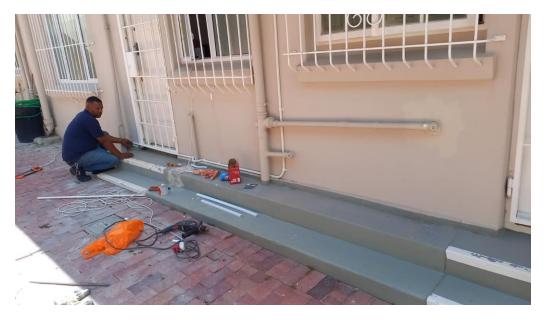
12h28

- Guys wiring up power for a sauna that's going to be installed. Confirmed to be Jane, permission has been given.
- Checked on lift doors, slight catching on ground floor but nothing serious.

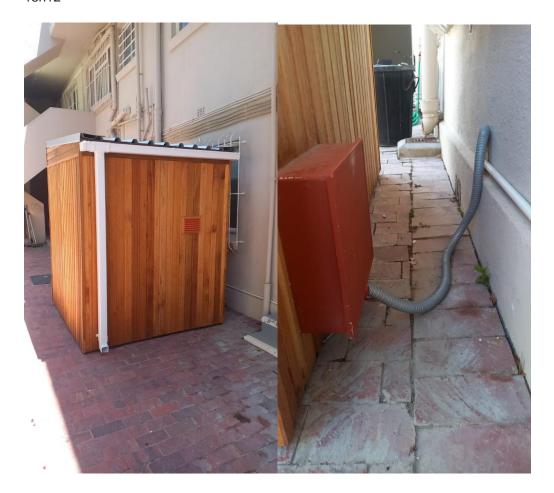
13h12

- Sauna is installed.
- Electrical looks sealed.

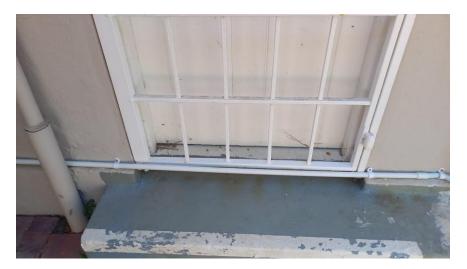
• Security gate will not be able to open with this conduit.

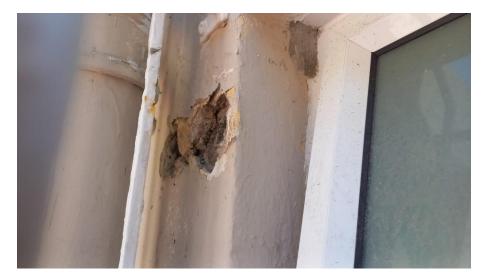
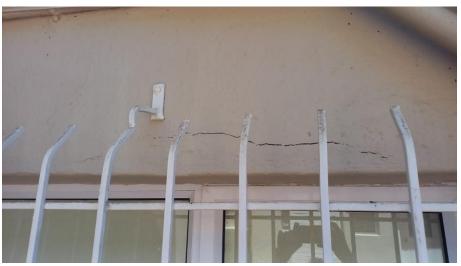
Cracking evident at Example court rear outside Joe's unit

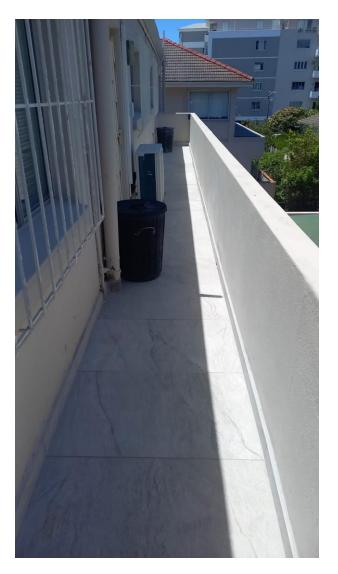
New tiling should prevent further damp damage in future. There is considerable water damage to soffit beneath that needs to be addressed now that waterproofing is considered finalised

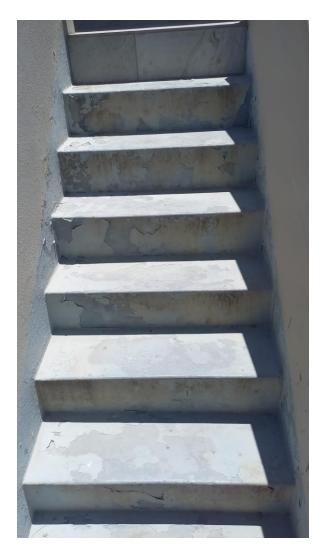
• Stairs in bad condition pre construction, agitated by construction activities, painting required

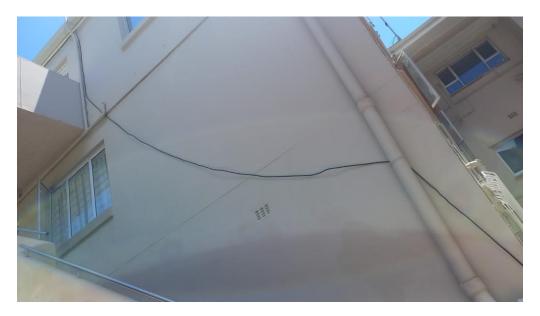
• Cable needing trunking/tubing, is to owners account

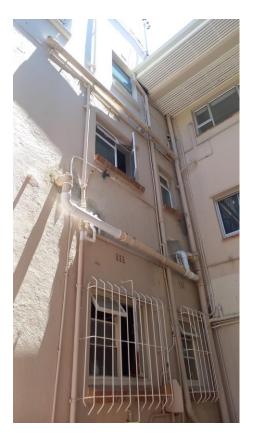
Pipes need painting and wall, first floor Example where the renovation was done

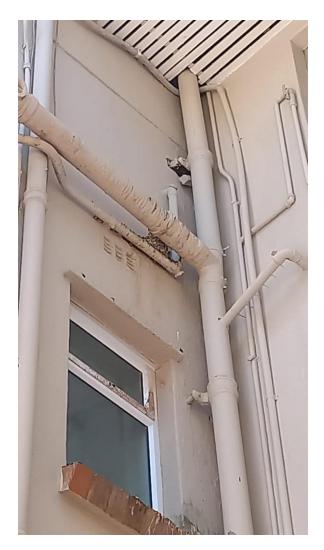
Bird spikes need to be installed and pipes cleaned along with the painting in the same area

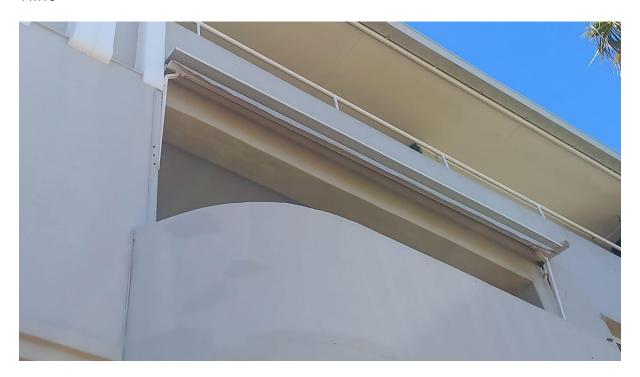
Cracking beam, first floor Example requiring attention

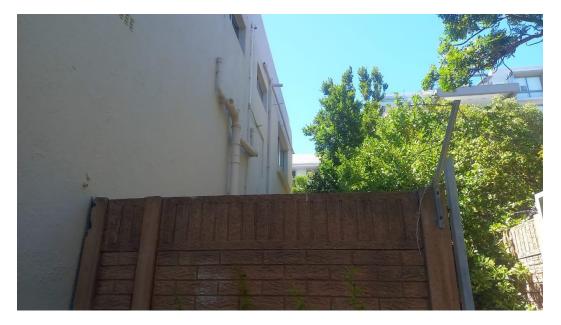
Barbed wire needed for Example back passage, quote requested by Joe

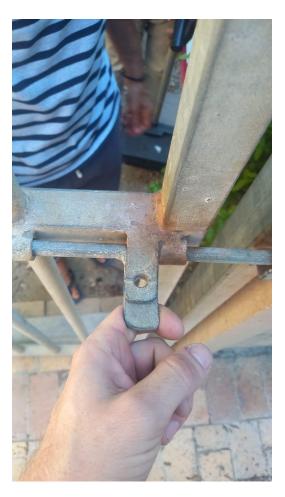
• New padlock with 4 keys requested by Joe, supplied this week

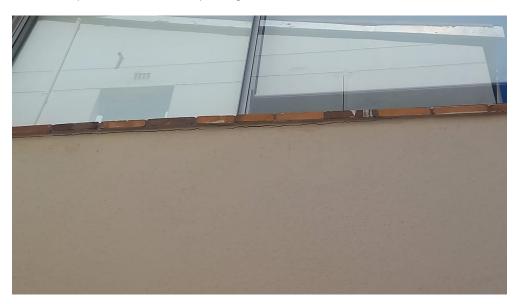
• Cracking appearing below window on same face

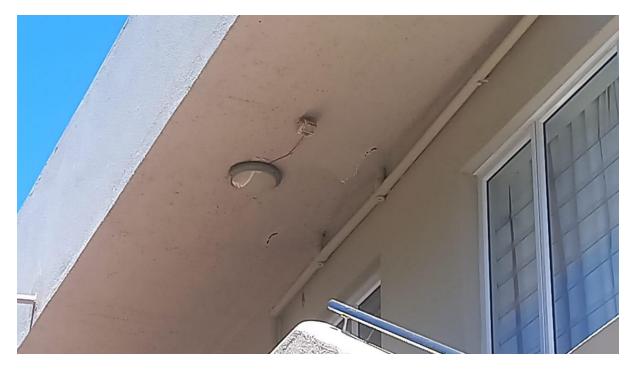
- Example rear, 2nd floor passage beneath newly tiled walkway showing water damage, requiring replastering and painting
- Lighting solution requested for loadshedding by Joe
- Budgetary estimates compiled for the end of next week.
